HISTORIC STRUCTURE REPORT:  
THE CUSTOM HOUSE AND TOWER

VOLUME II:  
EXISTING CONDITIONS AND RECOMMENDATIONS

SARA B. CHASE  
and  
ANNE A. GRADY

SOCIETY FOR THE PRESERVATION OF  
NEW ENGLAND ANTIQUITIES  
CONSERVATION CENTER

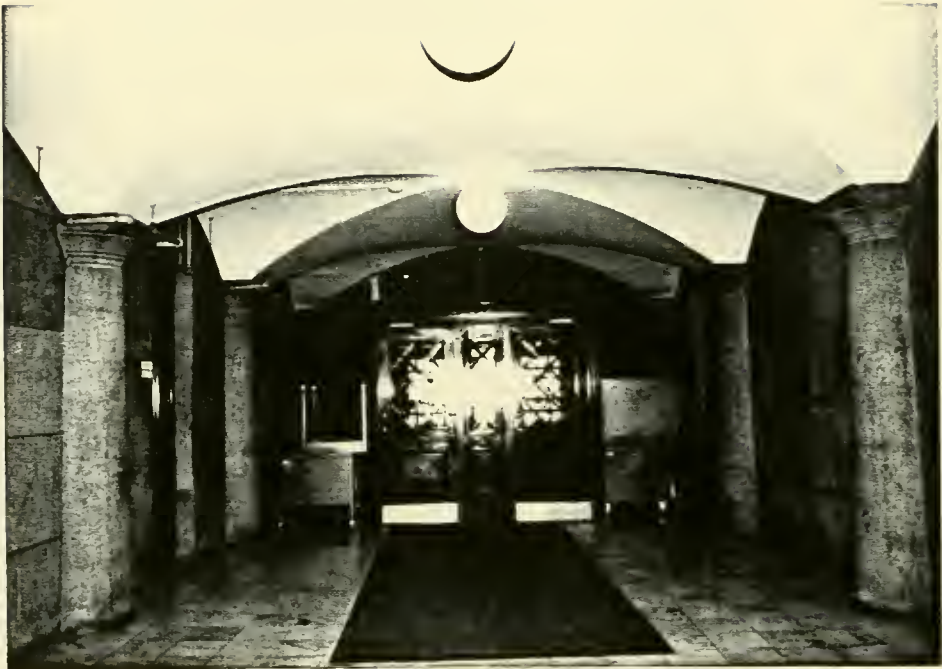
Element	Material/Description	Condition	Photo#
Floor	marble	highly waxed, joints dark, some chipped edges	B-5, 6
Base-board	none		
Walls	granite	dirty, floor wax on lower edges	B-5, 6
Cornice	none		
Ceiling	vaulted plaster	some cracks, peeling paint; ivory, cream, pale grey paints	B-5, 6
Windows	none		
Window Frames	none		
Doors	exterior: oak interior: grained metal	exterior needs refinishing, interior some chipped and crazed areas, some dirt	B-6, 7, 8
Door Frames	same as above		
Hardware	exterior: brass interior: brass	highly polished tarnished	B-6, 7, 8
Elec. Fixt.	frosted glass globes		B-5, 6
Special Features

B-6; South corridor, looking south.

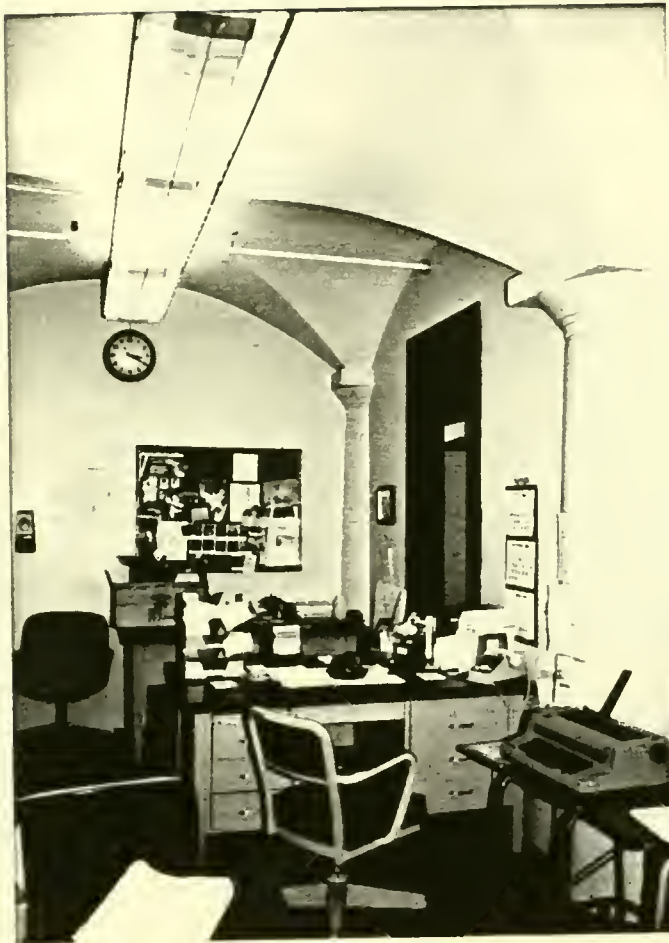
Element	Material/Description	Condition	Photo#
Floor	carpet over linoleum over granolithic (?)	fair	B-11, 12
Base- board	flat marble with black linoleum	some chips	
Walls	outer walls - granite; inner walls - plaster and metal	severe plaster and paint problems on south and west walls	B-11, 12
Cornice	picture rail	good	
Ceiling	plaster	water damage in large area, SW corner	B-11, 12
Windows	Kalamein	some corrosion, dirt	
Window Frames	grained metal	crazed and chipped in a few areas	
Doors	grained metal	(same as above)	
Door Frames	grained metal	(same as above)	B-8
Hardware	brass	tarnished	B-8
Elect. Fixt.			
Special Features	Small toilet room in NE corner of marble and porcelain	perfect shape	B-13
Remarks

B-11; Southwest office suite, looking south.

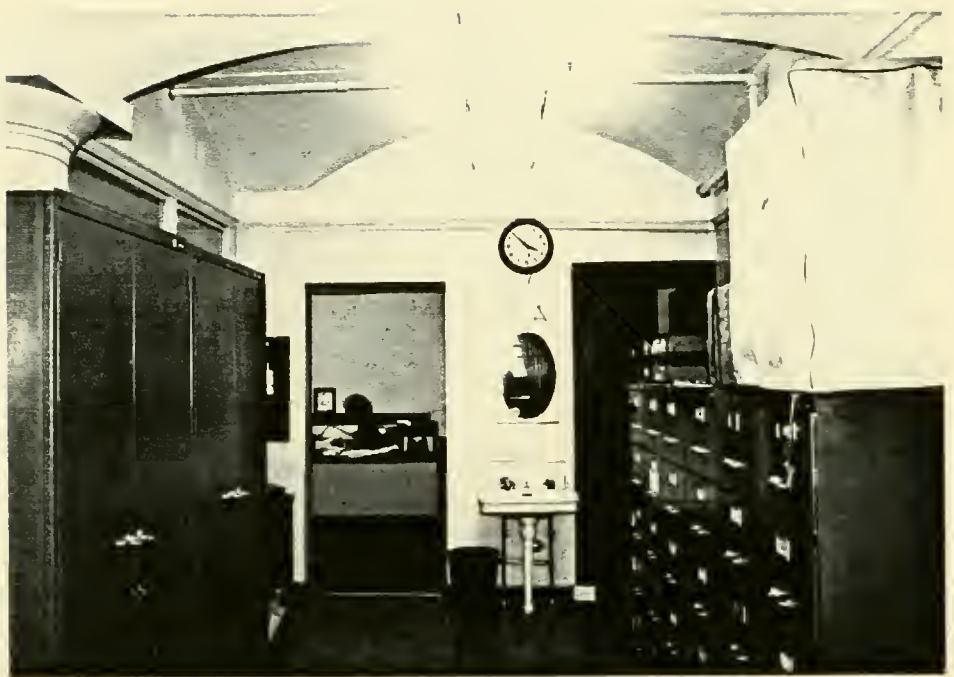
B-12; Southwest office suite, looking north.

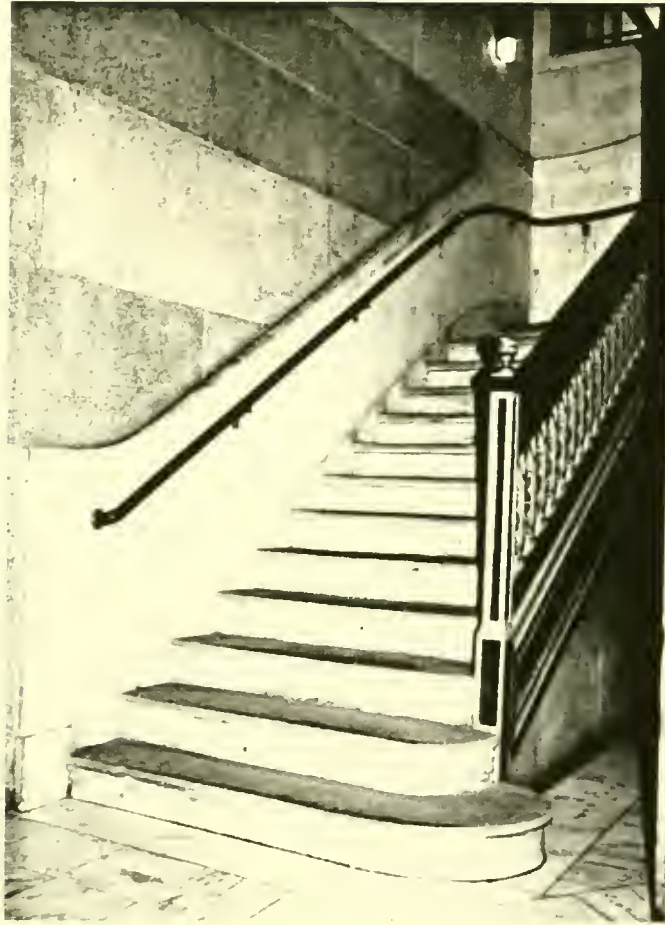
Element	Material/Description	Condition	Photo#
Floor	marble, granolithic	worn	B-17
Base-board	marble	soiled, slightly chipped	B-17
Walls	marble wainscot, granite above	very soiled, dulled by abrasive cleaning	B-17
Cornice	none		
Ceiling	flat plaster		
Windows	one, at turning of stair; Kalemeim	dirty	
Window Frames	Kalemeim		
Doors	none		
Door Frames	none		
Hardware	brass	tarnished	
Elect. Fixt.	frosted glass		
Special Features			
Remarks:	Granolithic treads on stairs are dull, worn and unsightly. Balustrade is iron and was originally painted bronze, black, deep green.

B-17; Stairs.

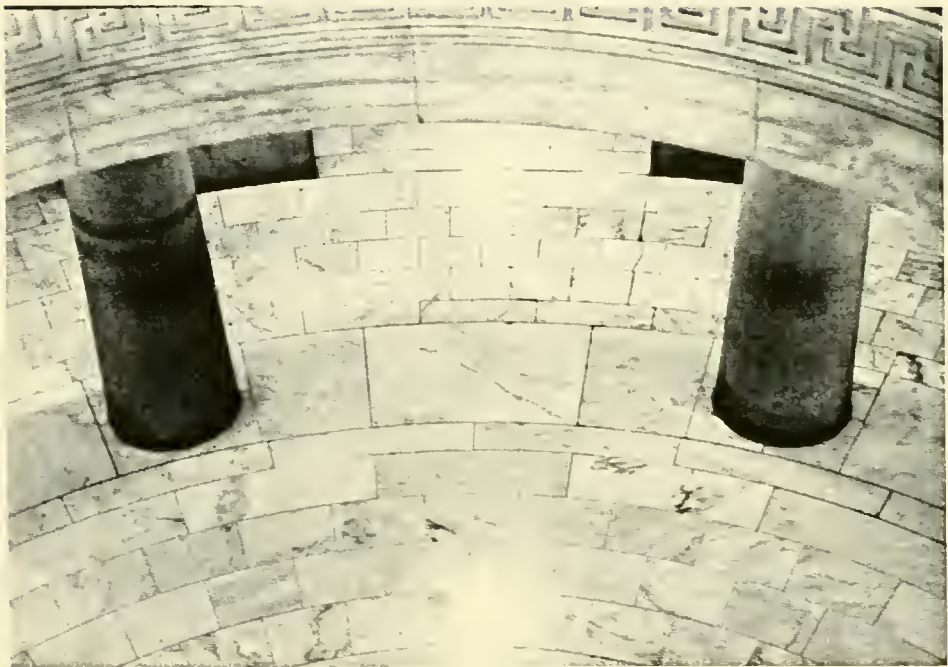
Material/Description		Condition	Photo#
Floor	white marble	good, but somewhat soiled with all joints blackened	B-1 B-18
Base-board	none		
Walls	granite	irregularly soiled, joints generally sound, some bad reprinting	B-2
Cornice	granite	fine, a bit dusty	B-15
Ceiling	flat plaster under gallery	good	B-1, 18, 1-4
Windows	none		
Window Frames	none		
Doors	oak (N & S only)	minor cleaning and touch-up varnish	
Door Frames	oak (N & S only)	(same as above)	
Hardware	brass	fine, but polish has spread onto wood	
Elect. Fixt.			
Special Features	granite columns	very soiled, especially at bases	B-1
Remarks: Signs have marred the granite walls in many areas; new grapevine joints not appropriate.

B-18; Floor of rotunda.

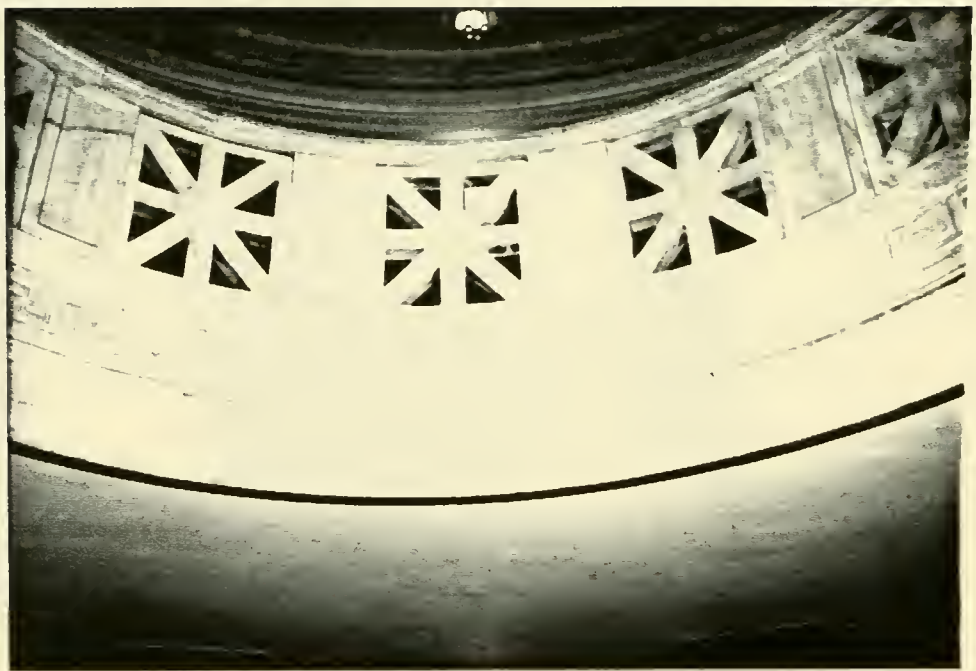
Element	Material/Description	Condition	Photo#
Floor	marble	some minor chips and scars, joints all blackened, well waxed, fairly clean	
Base-board	none		
Walls	marble	some staining - seems to have been abraded and coated (drips & streaks)	
Cornice	marble	good, dusty, some stains	
Ceiling	flat plaster	(under gallery only) - very good	
Windows	none		
Window Frames	none		
Doors	grained metal (glazed grille design N, W, E, S)	some minor cleaning & touching up needed - paint crazed and chipped	1-2, 3
Door Frames	marble, grained metal	good	1-5
Hardware	brass	good, but dull	
Elect. Fixt.	frosted spheres		
Special Features	marble gallery balustrade	scratched, abraded	1-1, 4
Remarks

1-4; Marble balustrade as seen from basement.

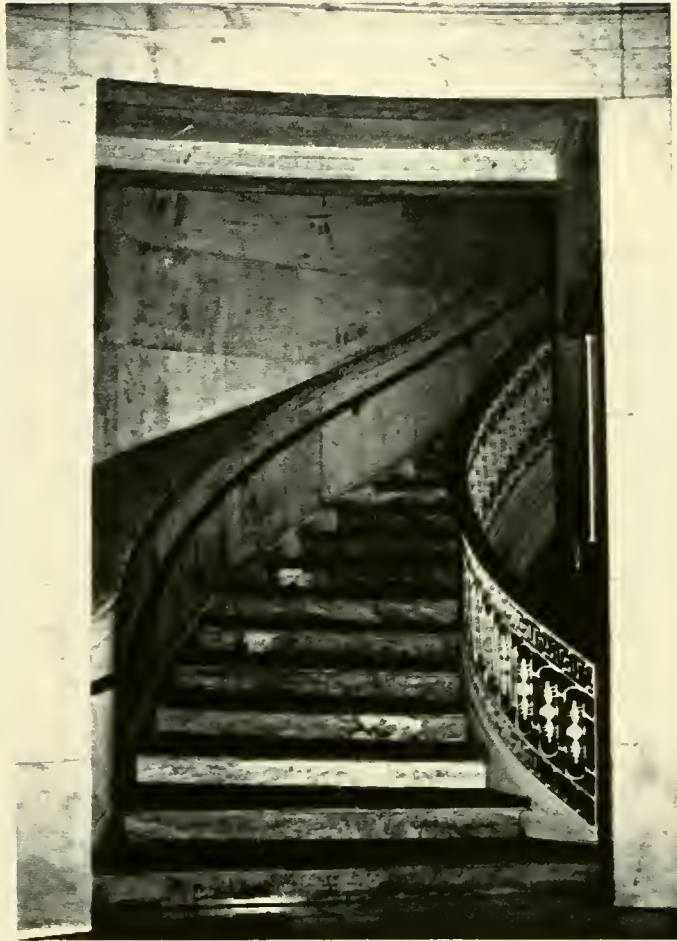
Element	Material/Description	Condition	Photo#
Floor	treads are marble with granolithic over	worn, dirty	1-6, 7
Base-board	marble, flat, part of wainscot	scoured, dirty	1-6, 7
Walls	marble	scoured, some dirt and streaks	
Cornice	none		
Ceiling	plaster	fine	
Windows	one Kalamein at turning of stair	dirty	
Window Frames	marble	dusty, rough	
Doors	none		
Door Frames	none		
Hardware	iron balustrade	repainted at least 3 times	1-6, 7
Elect. Fixt.			
Special Features	grille over window into elevator well	originally iron, painted pearl grey over red primer	1-8
Remarks

1-6; Stairs.

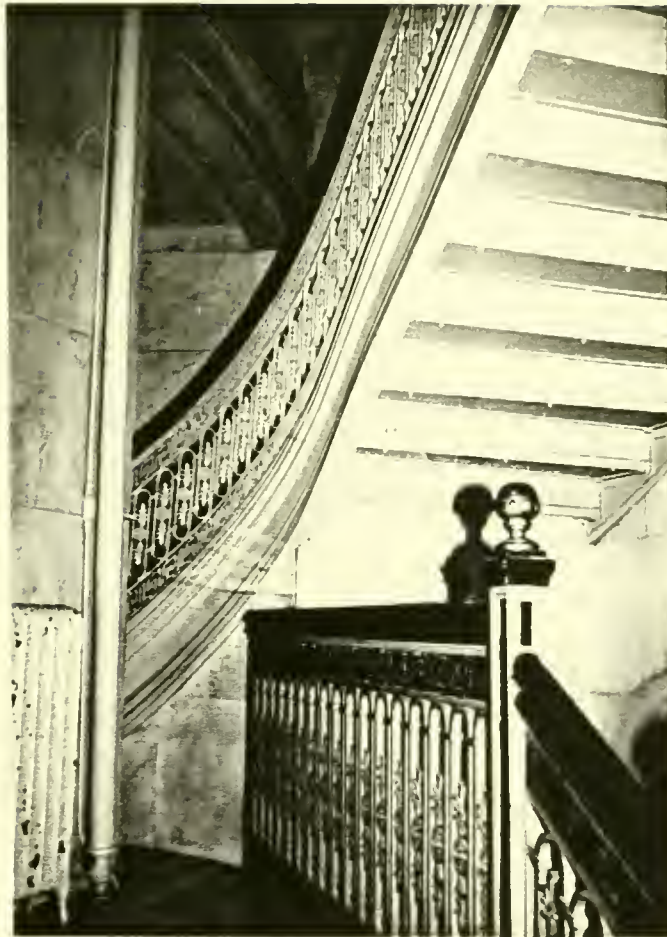
1-7; Stairs.

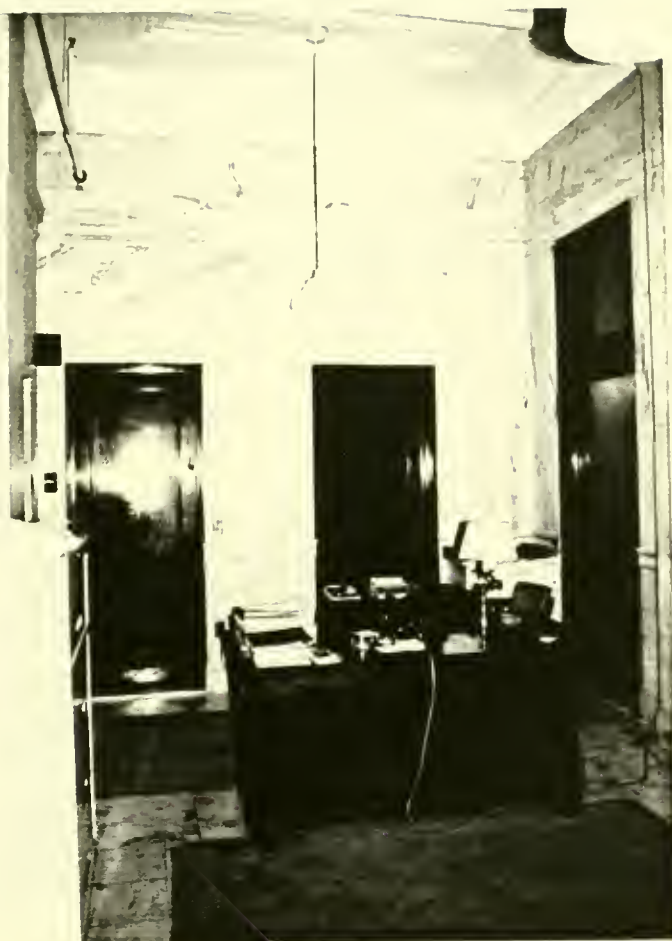
Element	Material/Description	Condition	Photo#
Floor	marble	good	1-9
Base-board	marble	some chips and scratches	1-9
Walls	marble	well polished and clean above wainscot, 1-9 scoured below	
Cornice	plaster	good	1-9
Ceiling	molded plaster panels	good	1-9
Windows	none		
Window Frames	none		
Doors	grained metal	good - minor touch-up needed	1-9
Door Frames	grained metal	(same as above)	1-9
Hardware	brass	dull	
Elect. Fixt.	hanging frosted glass	good	1-9
Special Features

1-9; Lobby, north wing.

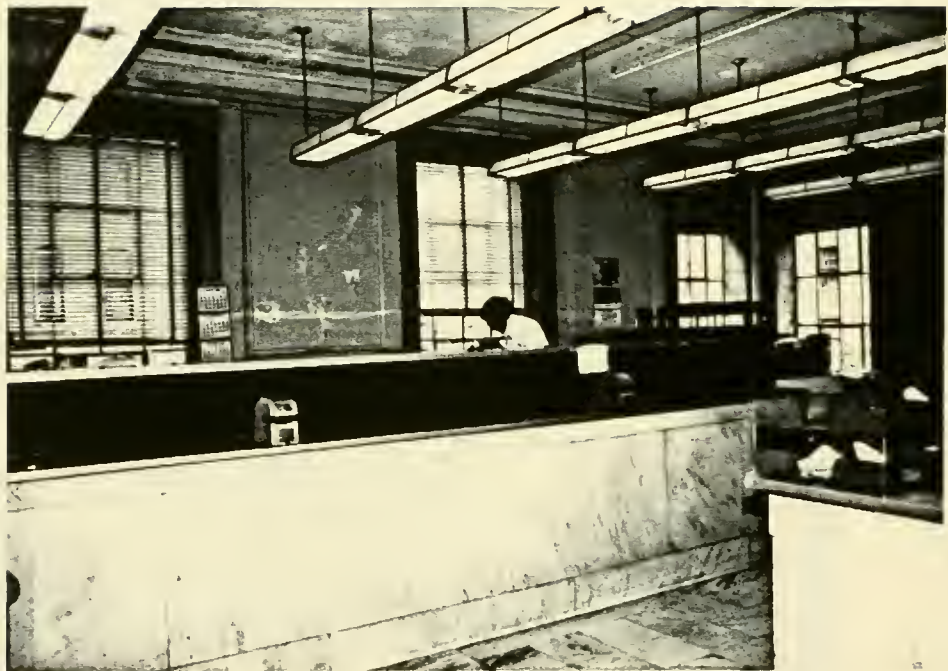
Element	Material/Description	Condition	Photo#
Floor	marble, carpet over in W	good	1-22
Base-board	marble	dirty, scratched	
Walls	marble wainscot plaster w/ panel molding	dirty, scratched some chips, E wall poor, W wall center poor	1-22, 23
Cornice	plaster	good except on E wall	1-22, 23
Ceiling	plaster - some coffering	good except E by center window	1-24
Windows	steel frame	dirty, rusted	1-22, 23
Window Frames	marble	dirty, some scratches	1-22, 23
Doors	painted metal glazed grille	need cleaning and paint touch-up	
Door Frames	grained metal	(same as above)	
Hardware	brass	dull	
Elect. Fixt.	egg crate		1-22, 23, 24
Special Features			
Remarks

1-22; South wing.

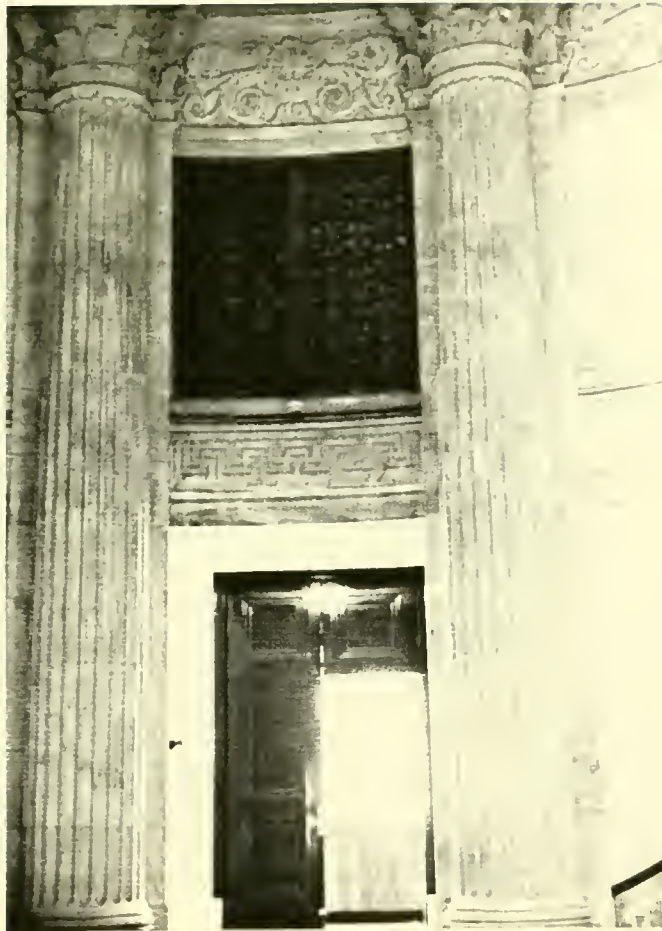
Element	Material/Description	Condition	Photo#
Floor	marble	highly polished, joints blackened, good condition	
Base- board	none		
Walls	marble	stained and soiled - evidence of coating gone yellowish - dull surface	2-1, 17
Cornice	plaster, unpolished marble in E & W niches	somewhat dirty, but good	2-17
Ceiling	dome	in W niches peeling badly	
Windows	none		
Window Frames	none		
Doors	grained metal	need cleaning & touch-up	2-5
Door Frames	marble	good - some chipping & soiling	
Hardware	brass	good, but dull	
Elect. Fixt.	hanging frosted spheres		2-4
Special Features

2-1; Rotunda, looking south.

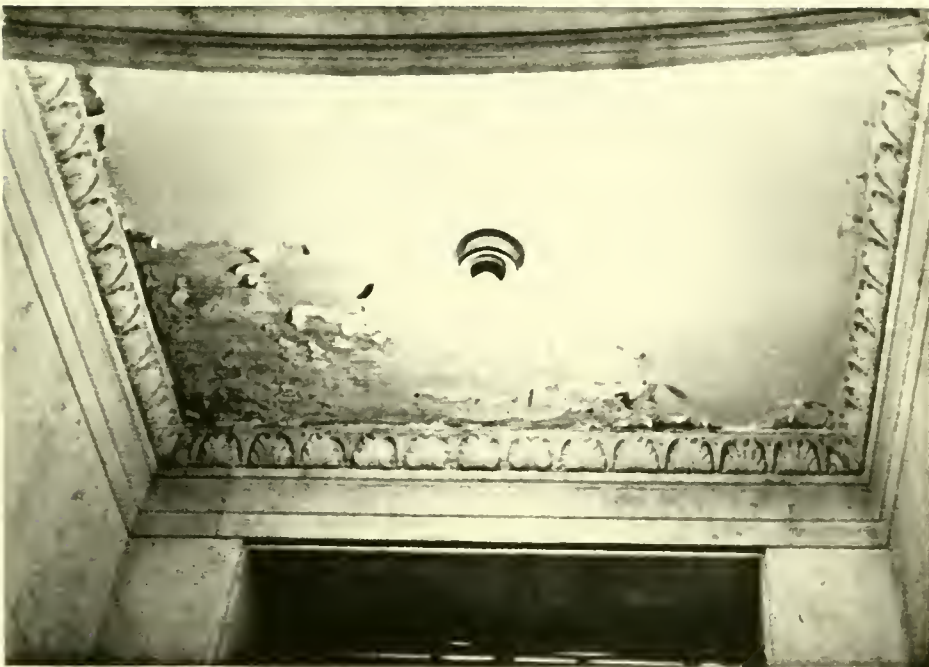
Element	Material/Description	Condition	Photo#
Floor	marble, marble steps	dirty	
Base-board	marble	dirty, dusty	
Walls	marble	slightly dirty	2-2
Cornice	marble	dusty	2-2, 3, 4
Ceiling	plaster	water damage, cracks	2-2, 3
Windows	Kalamein	dirty, some corrosion and streaks	
Window Frames	marble	dusty	
Doors	none		
Door Frames	none		
Hardware	none		
Elect. Fixt.	frosted spheres		
Special Features	W alcove has marble plaque identifying original Custom House	Black paint in letters is peeling	2-2
Remarks

2-3; Ceiling in west window alcove.

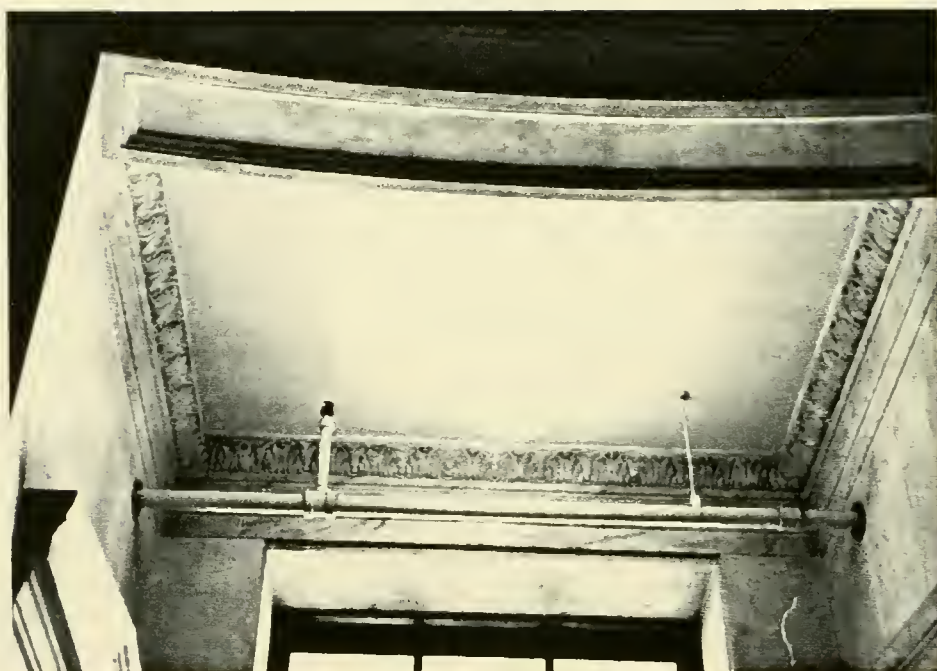
2-4; East window recess, ceiling.

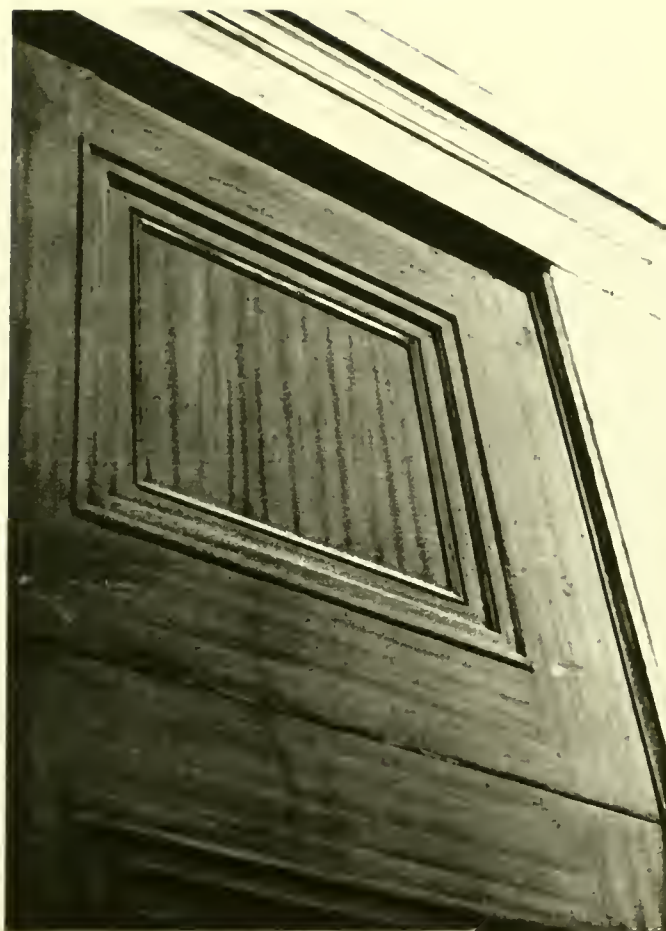
Element	Material/Description	Condition	Photo#
Floor	marble	good, slightly scratched, joints dark	
Base-board	marble, molded	minor nicks and scratches	
Walls	marble, panelled plaster	some soiling, abrasion on marble; plaster is good	2-6
Cornice	molded plaster	good, dusty	2-7
Ceiling	coffered plaster	good	2-7
Windows	frosted glass in metal	good, slightly dirty	2-6
Window Frames	grained metal	good, minor nicks	2-6
Doors	grained metal	good, minor scratches, chips	2-5
Door Frames	grained metal, marble	good	2-5, 6
Hardware	brass	tarnished	
Elect. Fixt.	egg crate		
Special Features			
Remarks

2-5; Detail, door to north wing.

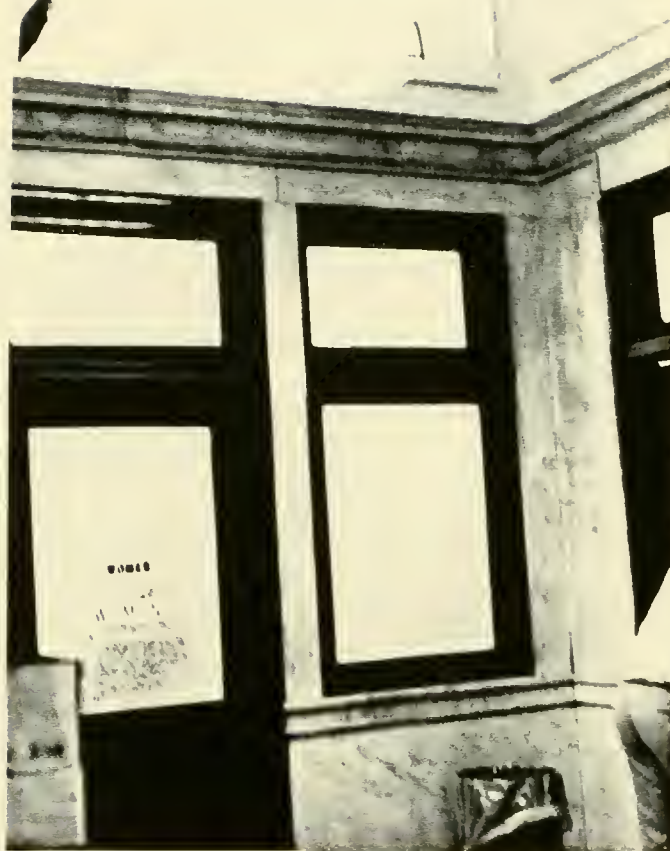
2-6; Lobby, north wing.

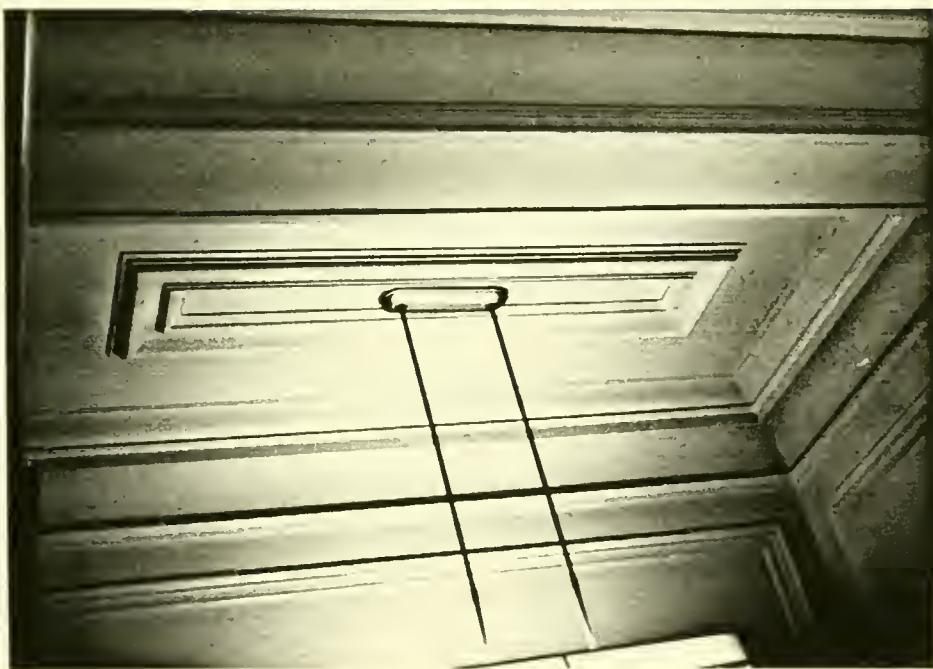
2-7; Ceiling in Lobby, norht wing.

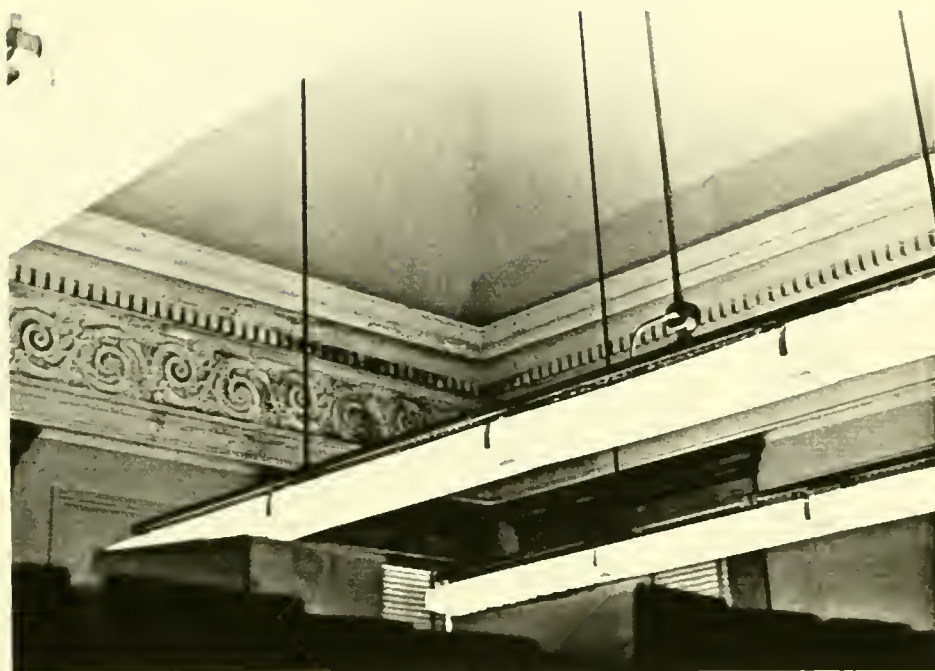
Element	Material/Description	Condition	Photo#
Floor	carpet over ?	poor	
Base-board	marble, molded	scratched & dirty - fair	2-14, 15
Walls	paneled plaster over low marble wainscot	some dirt, scratches, chips, abrasion	2-14, 15, 16
Cornice	molded plaster and rinceau	NE & NW corners - missing - much water damage	2-9
Ceiling	coved plaster	good except small spot in center & NE & NW corners, and N side	2-9, 10, 11, 12, 13
Windows	steel sash	corroded	
Window Frames	marble	soiled, dull, nicked	2-9, 11, 13
Doors	grained metal	painted over on rotunda side; needs cleaning and touch-up	
Door Frames	grained metal architraves	need cleaning and touch-up	
Hardware	brass	dull	
Elect. Fixt.	egg crate		2-9
Special Features			
Remarks

2-9; Ceiling - Auditor's room, south wing, southeast corner.

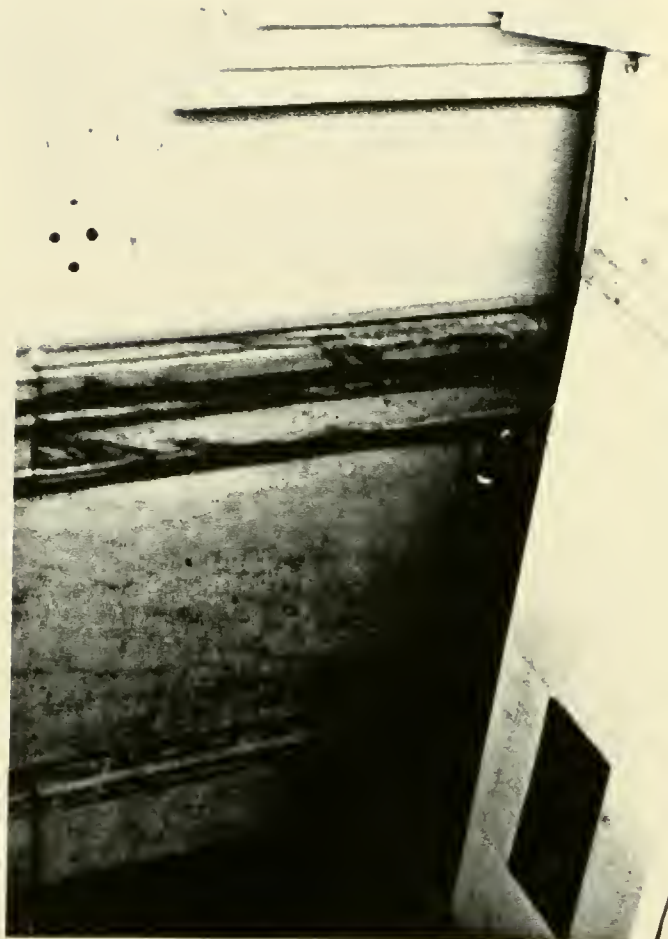
2-14; Auditor's room, north wall, behind water fountain.

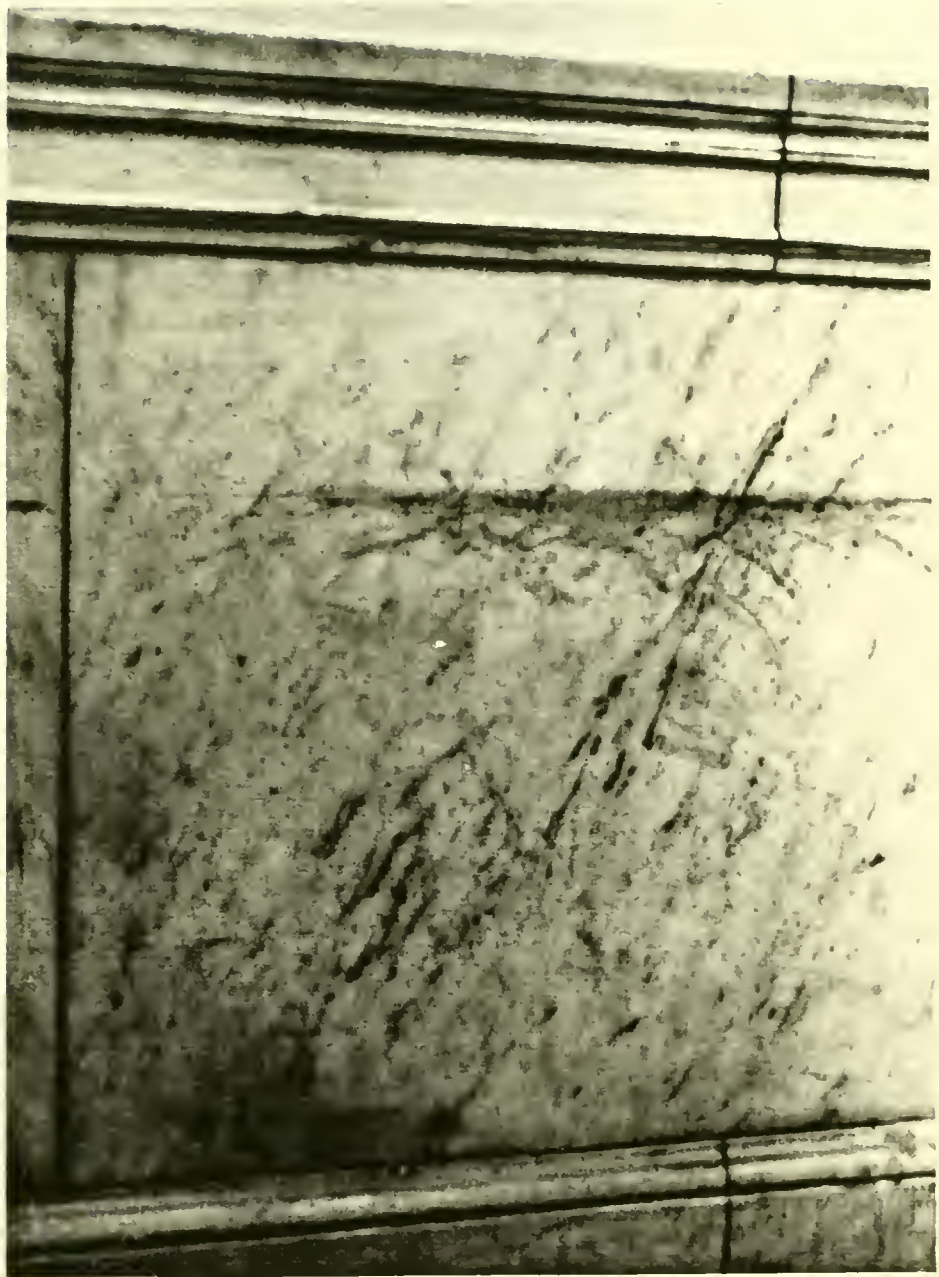
2-15; Auditor's room, wainscot on north wall,  
to west of main door.

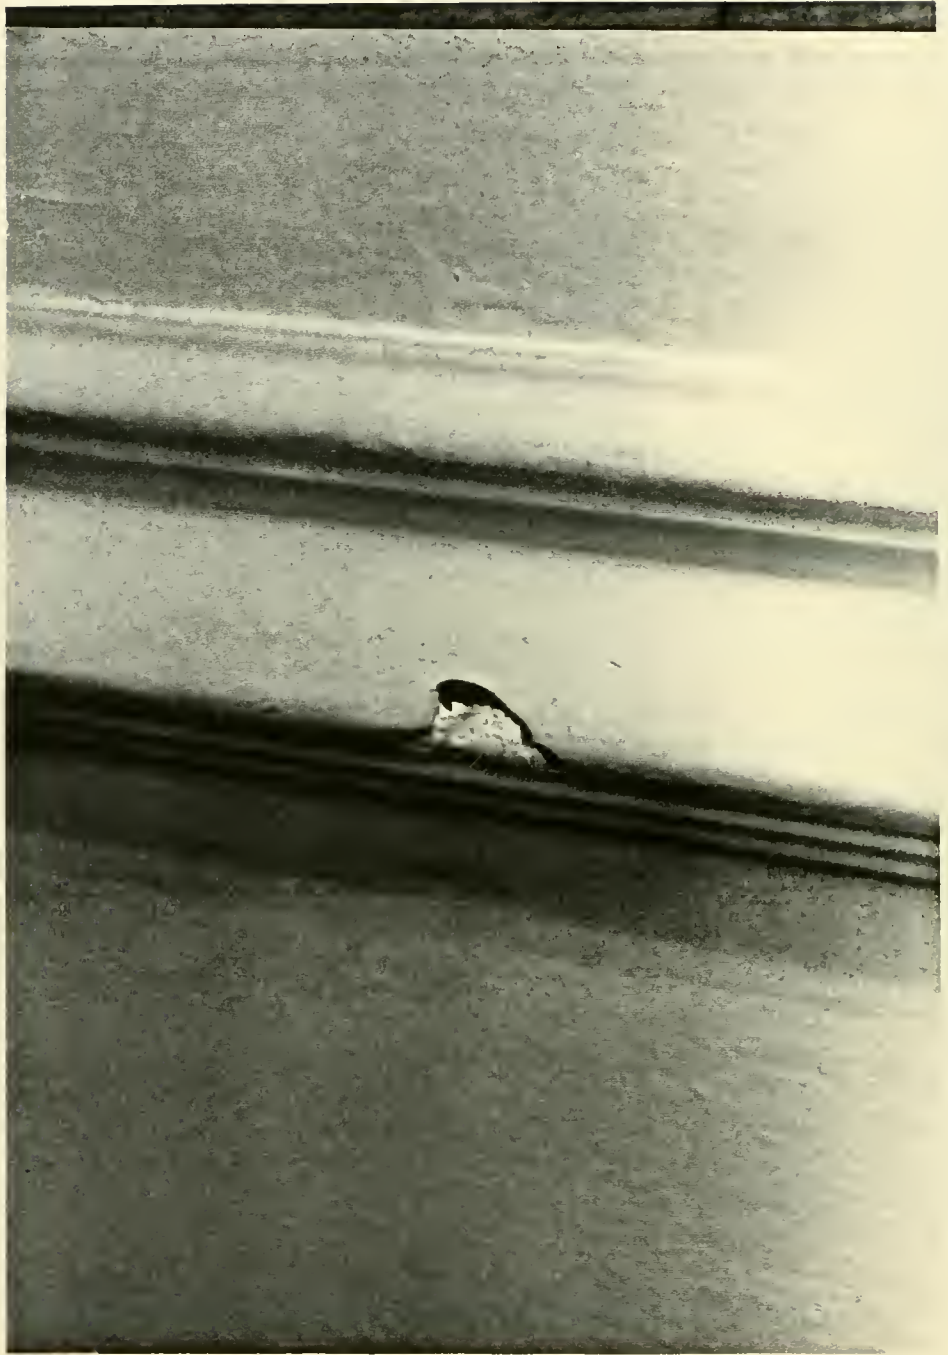
2-16; Auditor's room, moulding on plaster wall  
above wainscot, north wall.

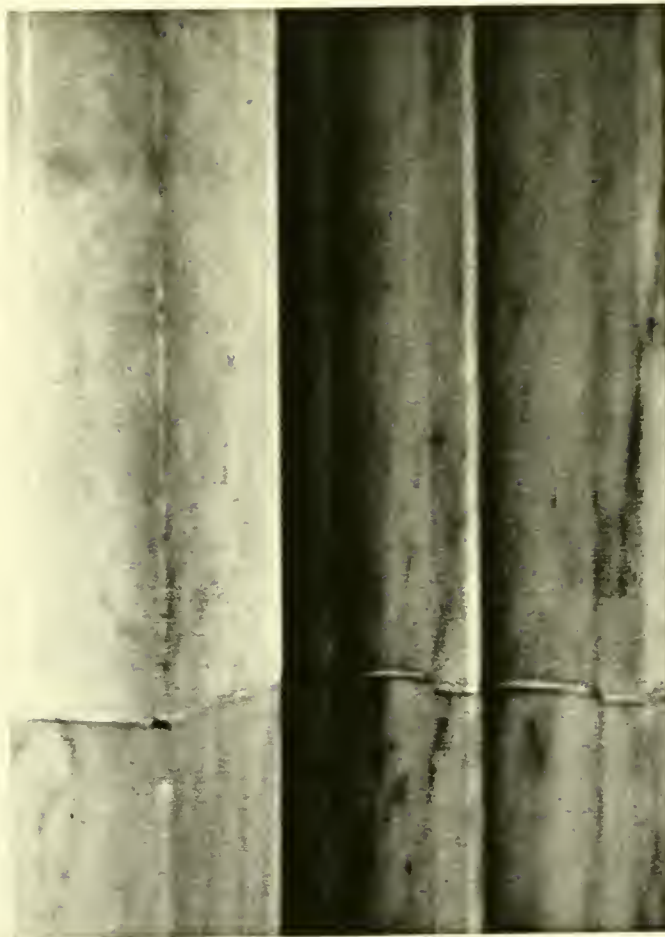
2-17; Typical joint in fluted marble columns of rotunda.

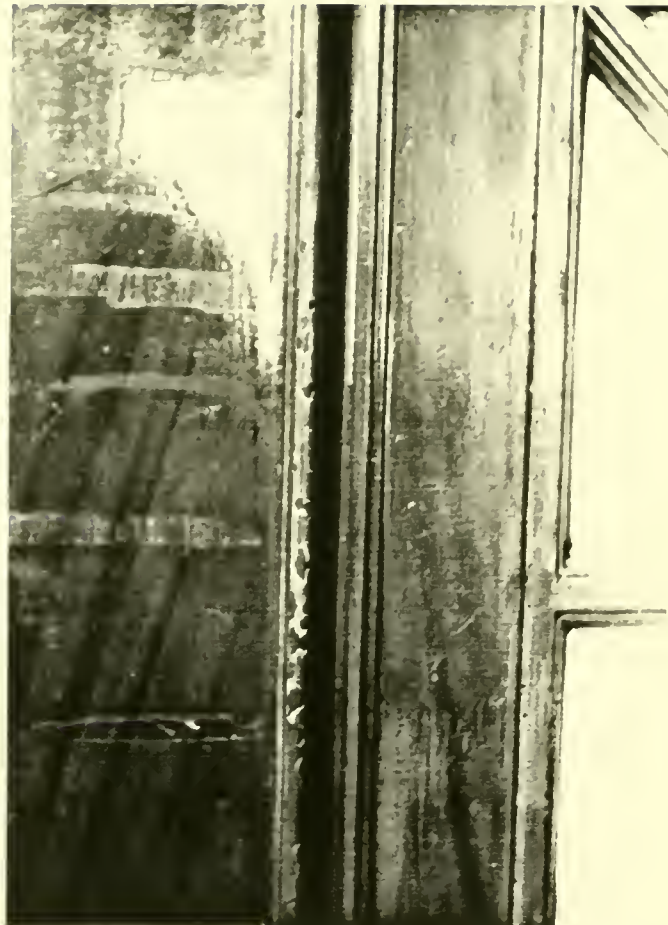
29 - View of typical frames: nicked and chipped, and streaked by careless cleaning.

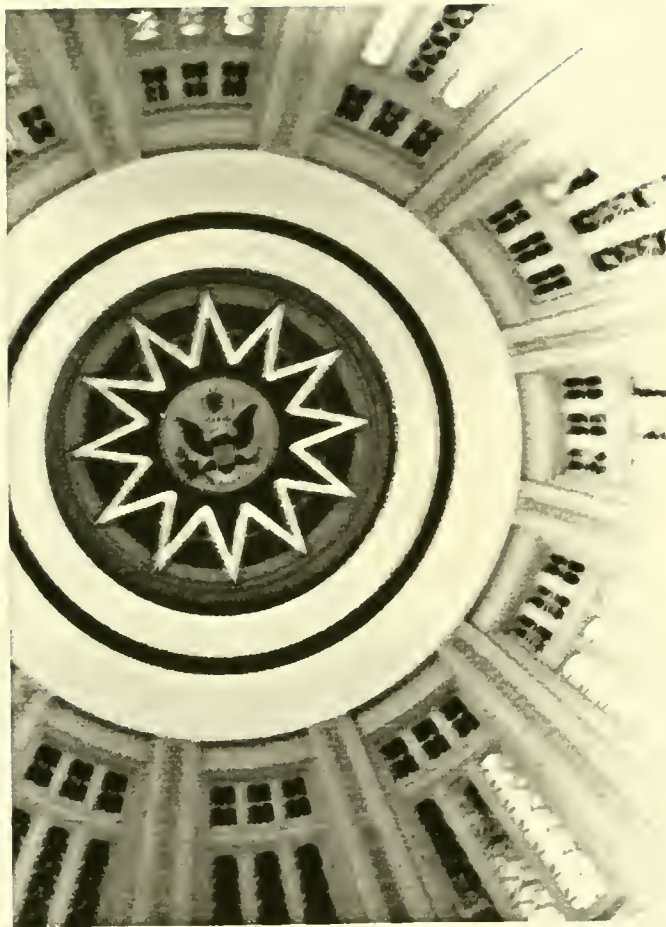
33 - View of 1950 painted steel star and seal and surrounding plasterwork in rotunda.

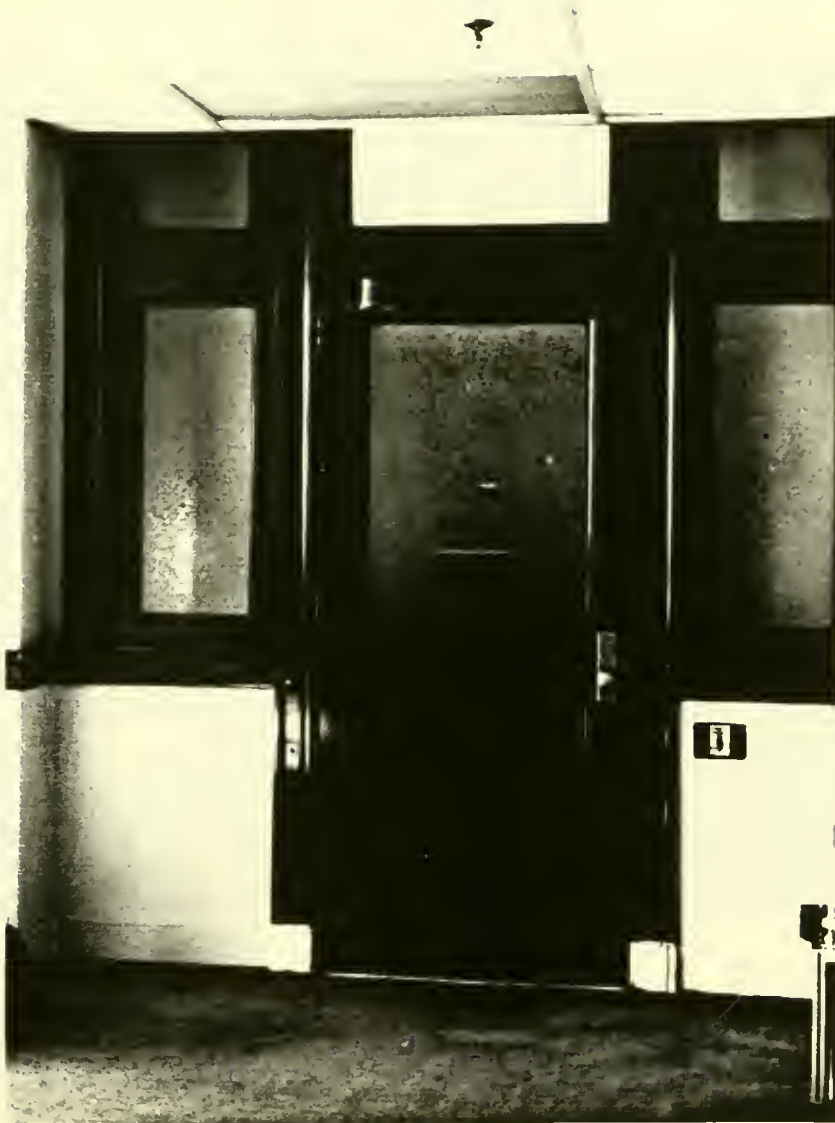
Figure 35

Element	Material/Description	Condition	Photo#
Floor	concrete	covered	
Base-board	painted orange terra cotta	chipped - 10%-20%	35
Walls	plaster, painted metal chair rail	good	
Cornice	none		
Ceiling	plaster above dropped acoustical	fair	
Windows	wood, Kalamine marble sills	(remove air conditioners) fair to good - needed paint & cleaning	34
Window Frames	grained (painted) metal	some chips	
Doors	painted grained metal frosted & clear glass	good, some chipped	35
Door Frames	(cf. above)	good	35
Hardware	modern brass-plated	good	35
Elect. Fixt.	egg-crate	good	36
Special Features			
Remarks:

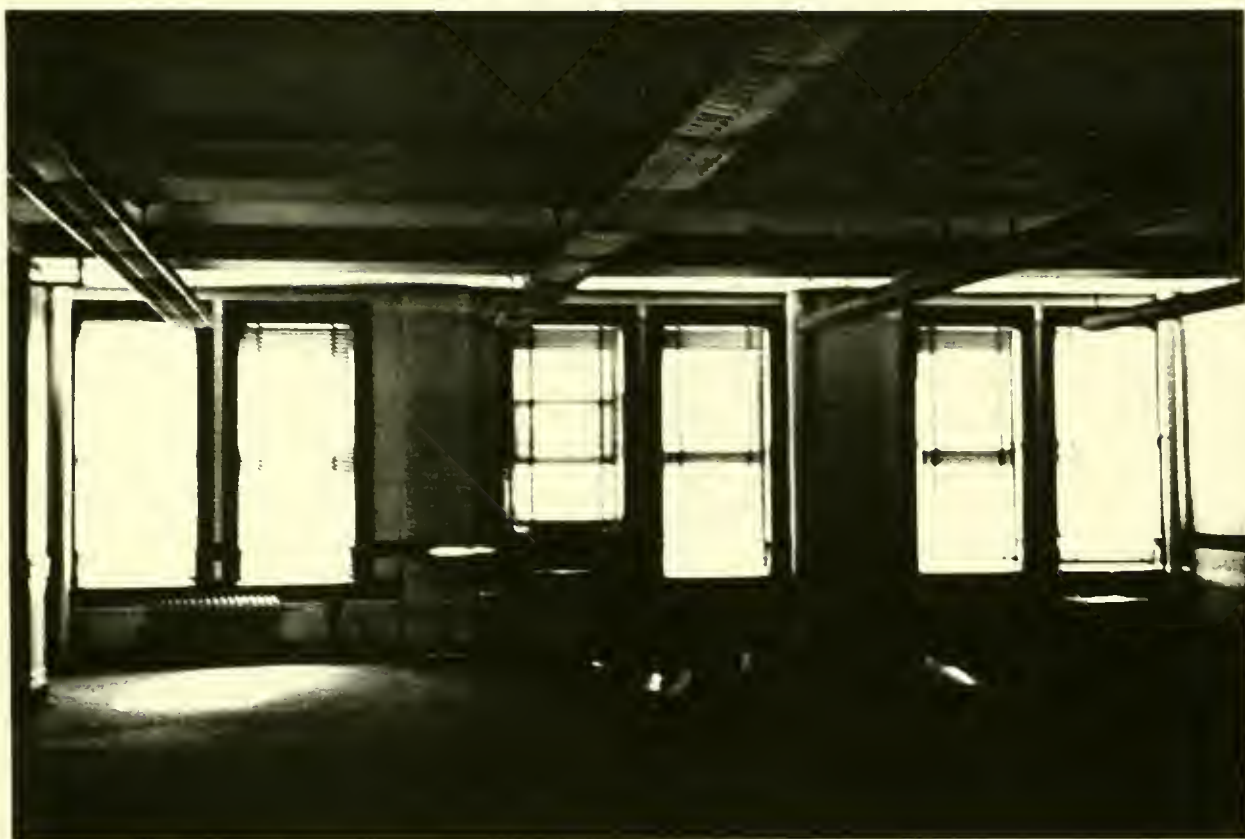
Figure 37

Element	Material/Description	Condition	Photo#
Floor	linoleum	worn, dirty	
Base-board	painted terra cotta	chipped	
Walls	plaster	fair to good - 20% peeling paint	
Cornice	none - some picture rail	fair	
Ceiling	dropped acoustical tile	fair	
Windows	same	corroded and dirty, chipped marble	37
Window Frames	same	blistered paint	37
Doors	same	(same as above)	37
Door Frames	same	(same as above)	
Hardware	same		
Elect. Fixt.	same		
Special Features			
Remarks:

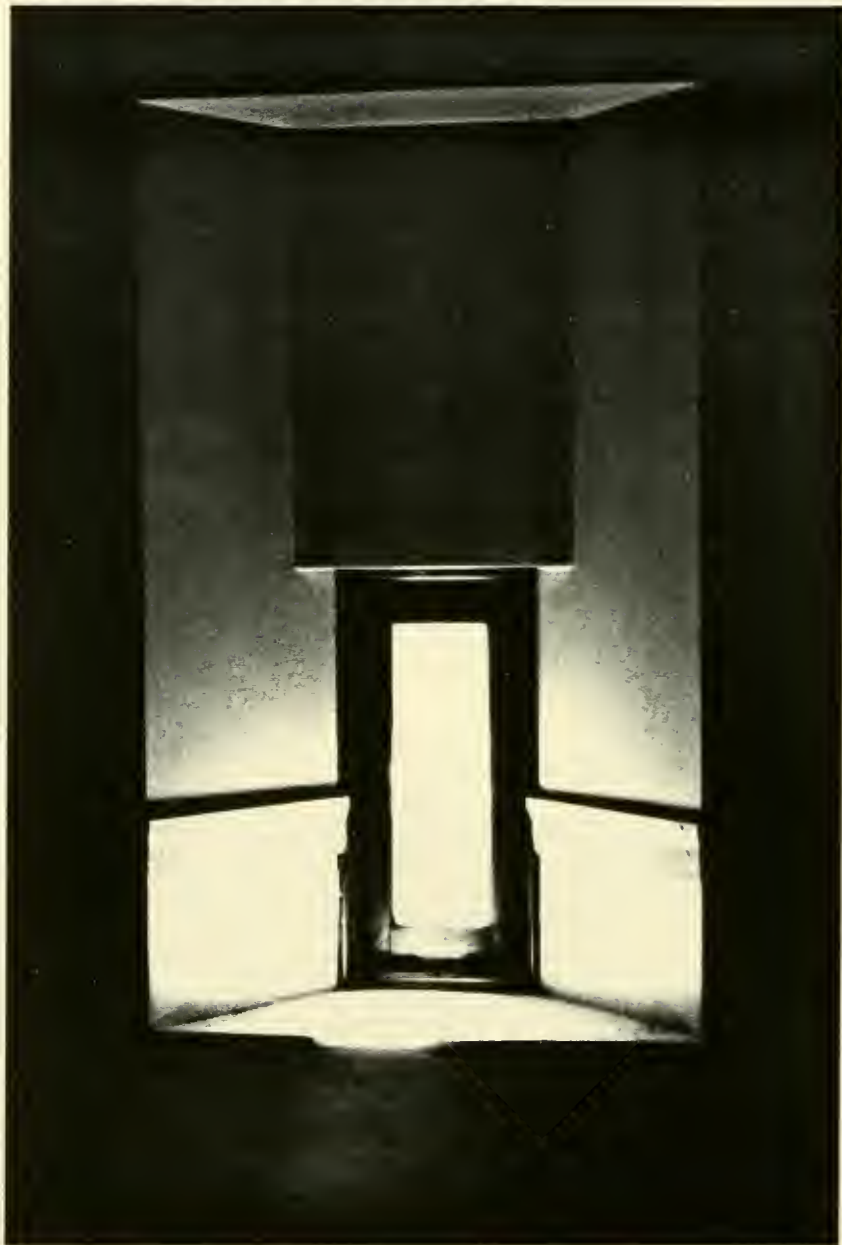
Figure 40

Element	Material/Description	Condition	Photo#
Floor			
Base-board			
Walls		25% peeling paint	
Cornice			
Ceiling			
Windows			40
Window Frames			
Doors			
Door Frames			
Hardware			
Elect. Fixt.			
Special Features			
Remarks: Typical of floors 6-18 but less fancy than the ninth floor.

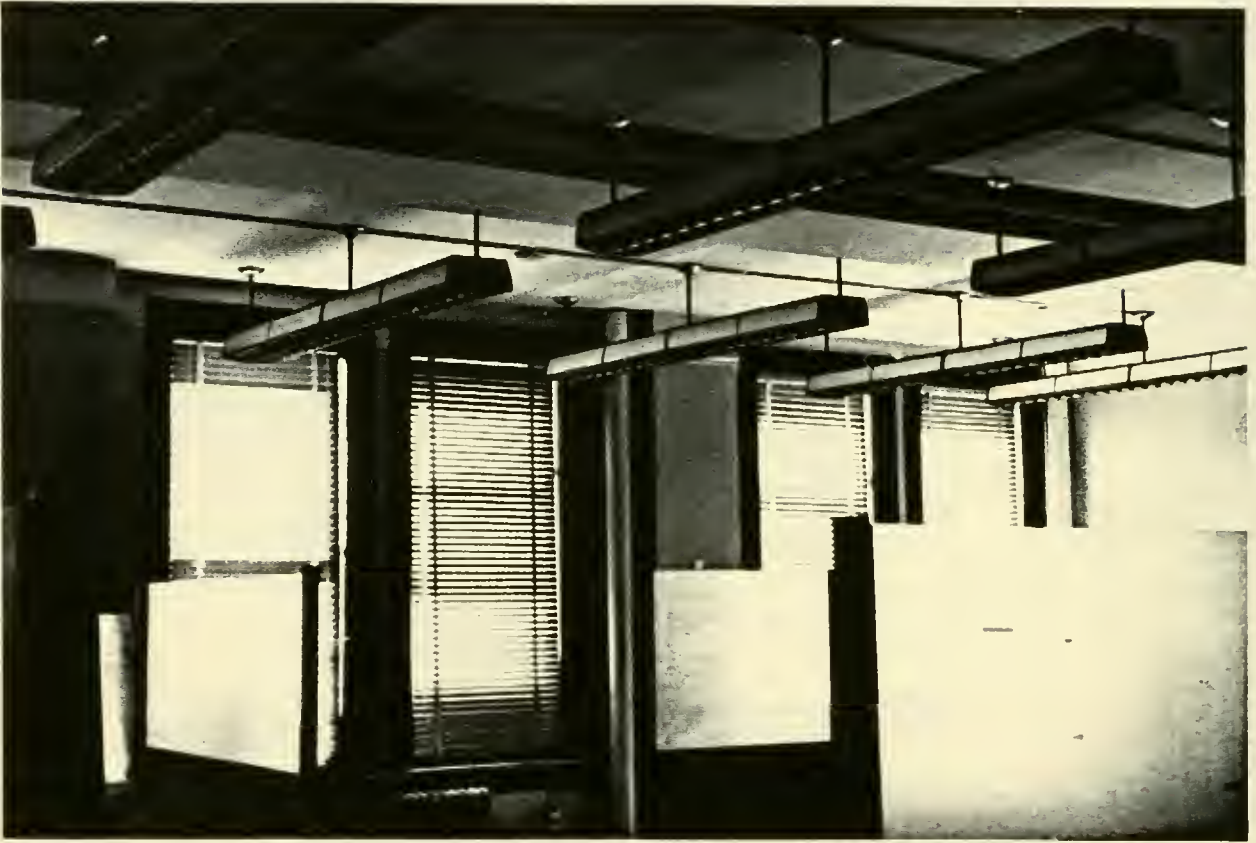
Figure 42

Element	Material/Description	Condition	Photo#
Floor	carpet		
Base-board			
Walls			42
Cornice			
Ceiling			
Windows			
Window Frames			
Doors			
Door Frames			
Hardware			
Elect. Fixt.			
Special Features			
Remarks: Open now. All typical--lots of plaster and water damage on East.
